**An investigation of head clogging on
transverse-scan video tape recorders**

RESEARCH REPORT No. PH-26

**THE BRITISH BROADCASTING CORPORATION
ENGINEERING DIVISION**

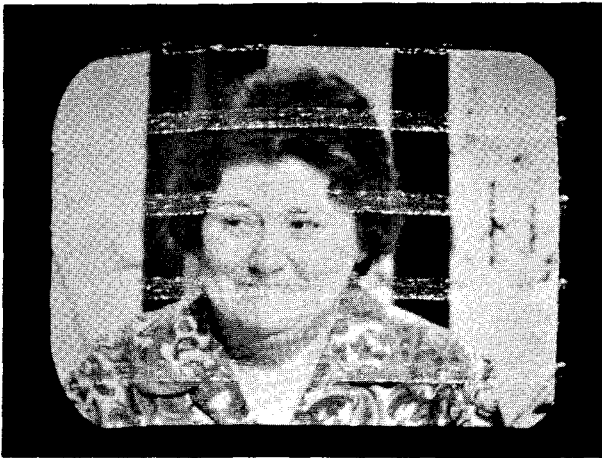
Fig. 3 - Head banding due to head clogging

until bands of noise appear across the picture (head banding), as depicted in Fig. 3. Head banding is visible at an earlier stage if no drop-out compensator is in use. Total break-up of the picture is frequently the final result although self-clearing incidents are not uncommon.

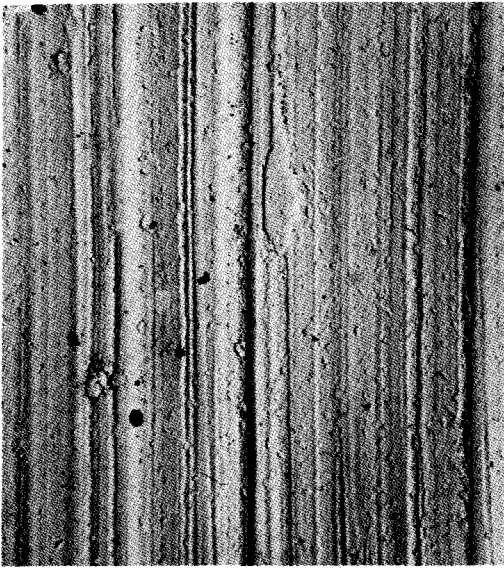
Fig. 10 - Electron-photomicrographs of a new pole-tip

(a) x4000

(b) Gap region x20,000; arrows indicate edges of gap

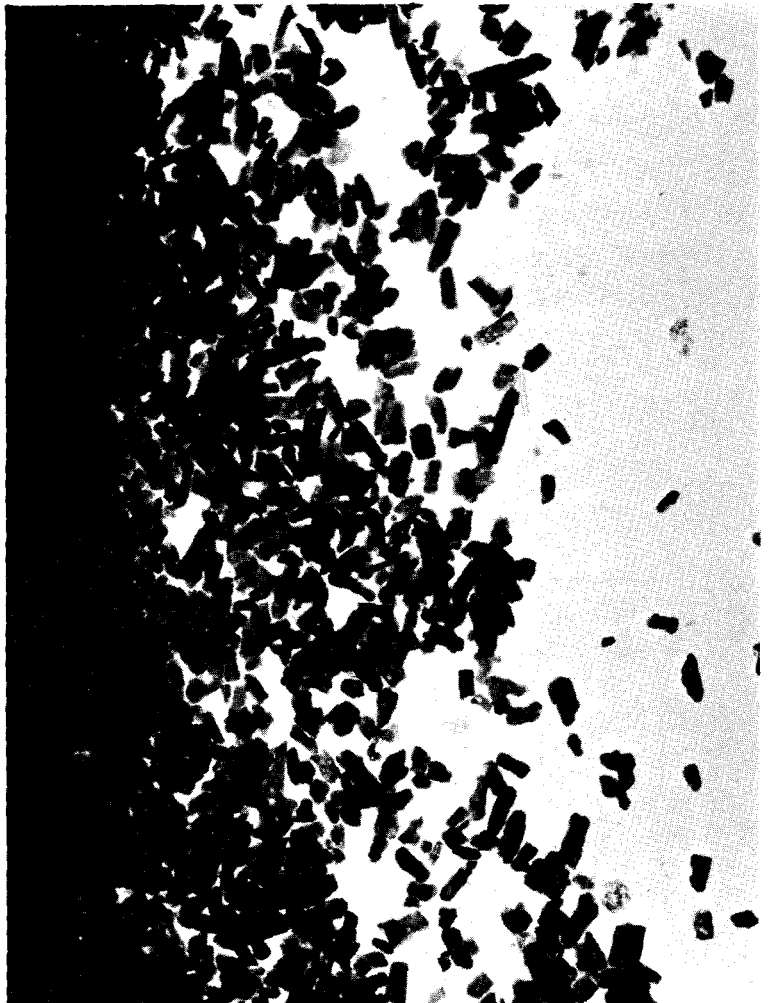
Fig. 11 - Electron-photomicrographs of a pole-tip after 100 operation-hours

The nature of the debris appearing on headwheels, especially when clogged, is clearly pertinent in the investigation. Fig. 11(b) strongly indicates that in the case of the particular pole-tip examined there the debris emanated mainly from the tape coating (see Section 3.10). However, in order to build up a statistically significant picture of headwheel debris, an attempt was made to utilize the evidence picked up by cotton buds which were then used in cleaning headwheels. For some months during the controlled period of operations in Wales all cotton buds used there were retained for analysis. At the same time, the Fulmer Research Institute, acting on behalf of Research Department, engaged Yarsley Testing Laboratories to attempt an infra-red spectroscopic analysis of two cotton buds used in cleaning a clogged headwheel. The sample of the headwheel deposit was extracted with methyl ethyl ketone but there was not enough extract to permit an infra-red examination. The more strongly stained cotton wool fibres were then collected and ground with potassium chloride to a fine powder. The powder was pressed to form a disc, and the latter was examined in an infra-red spectroscope. The spectral bands of cotton wool were obvious but they masked any other bands, thus precluding the identification of any other materials. Identification would have been possible if the sample quantity had been larger, but the sample supplied was already exceptionally large as it was taken from a heavily clogged headwheel. Samples from clogged headwheels could have been grouped but this would have obscured the individual characteristics of each clogging incident, thereby substantially nullifying the usefulness of the analysis. Collection of cotton buds in Wales was stopped after the results of these trial analyses became known.
